DEPARTMENT OF TRANSPORTATION

Contract #: 04-0120F4Cty: SF/ALA Rte: 80 PM: 13.2/13.9File #: 69.28**WELDING INSPECTION REPORT****Resident Engineer:** Pursell, Gary**Address:** 333 Burma Road**City:** Oakland, CA 94607**Report No:** WIR-015101**Date Inspected:** 22-Jun-2010**Project Name:** SAS Superstructure**OSM Arrival Time:** 700**Prime Contractor:** American Bridge/Fluor Enterprises, a JV**OSM Departure Time:** 1900**Contractor:** Zhenhua Port Machinery Company, Ltd (ZPMC), Changxing Island **Location:** Shanghai, China**CWI Name:** Li Yang**CWI Present:** Yes No**Inspected CWI report:** Yes No N/A**Rod Oven in Use:** Yes No N/A**Electrode to specification:** Yes No N/A**Weld Procedures Followed:** Yes No N/A**Qualified Welders:** Yes No N/A**Verified Joint Fit-up:** Yes No N/A**Approved Drawings:** Yes No N/A**Approved WPS:** Yes No N/A**Delayed / Cancelled:** Yes No N/A**Bridge No:** 34-0006**Component:** OBG**Summary of Items Observed:**

OBG SEGMENT 8CW

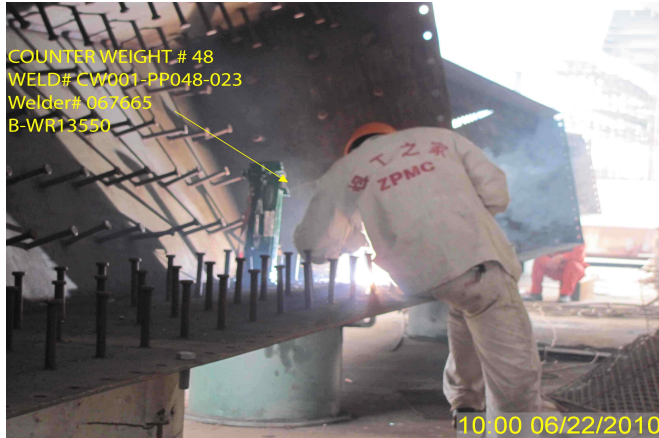
Unless otherwise noted, all work observed on this dated appeared to generally comply with applicable contract documents.
